The Philadelphia Girls' Rowing Club: An
Incremental Historic Structure Report

**THE PHILADELPHIA GIRLS' ROWING CLUB:
AN INCREMENTAL HISTORIC STRUCTURE REPORT**

Anna Stillner

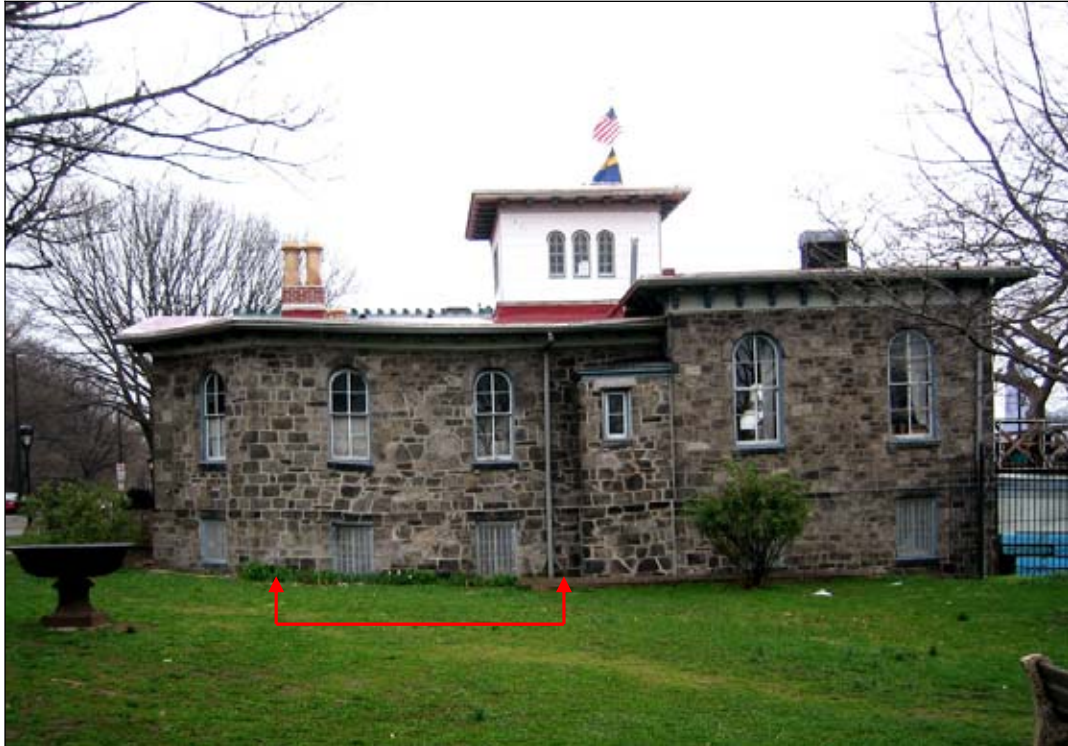
Figure 20: West elevation, arrows indicate where structural stabilization project occurred, 2003.
(Photograph by author)

The work primarily took place beneath the front two westerly windows, where visual damage is extreme. First, he installed mini-piles, or three-inch pipes, on either side of the wall and casted a concrete yoke beam onto either side, as well. Mini-piles were founded in that and a concrete beam was locked to the wall. This was done through tunneling and casting the concrete beam across. In addition, a needle beam was inserted through the wall and tied to the concrete on the sill. The idea was to lock the building to prevent further settlement. Mr. Dowd stresses that he did not attempt to raise the settled portion of the building, since such an operation would create significant risk to the walls, framing systems, finishes, and mechanical systems. After monitoring the building's movement

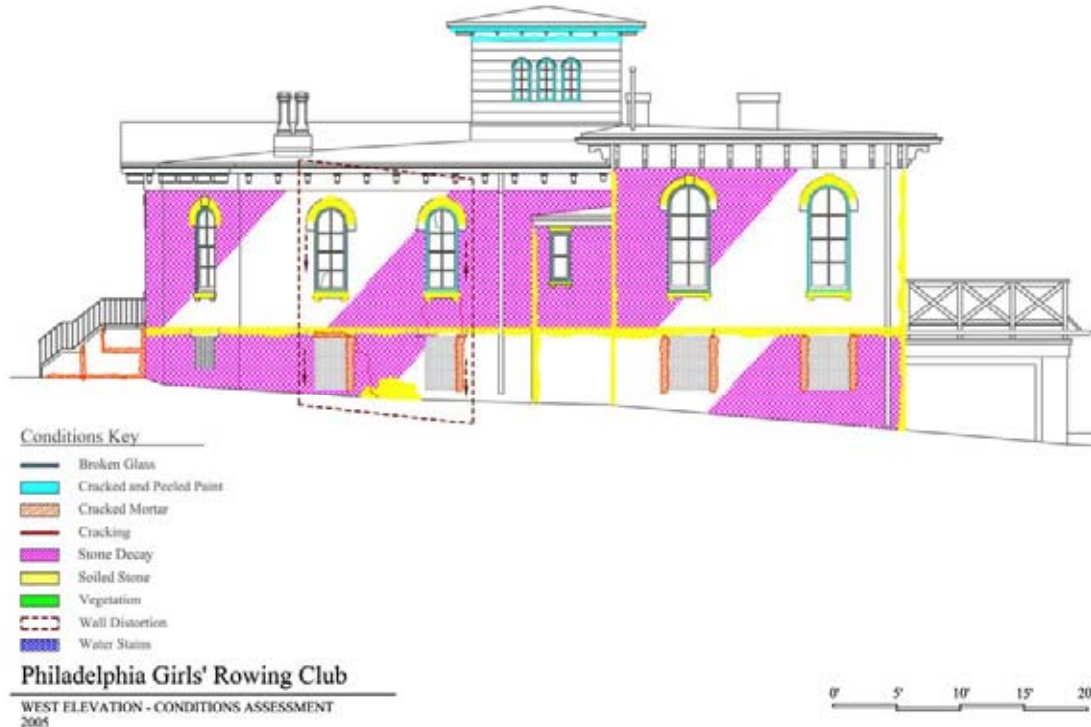
Drawing 10: West Elevation, Conditions Assessment (AutoCAD drawing by author, 2005)

Standing upriver from the Philadelphia Girls' Rowing Club and looking at its western elevation, one can see prominent misalignment of the window sills, indicating structural damage due to differential settlement of the masonry walls. [*Please see Appendix D for exterior photographs showing window distortion.*] According to Thomas V. Dowd, a structural engineer who has done extensive work on the boathouse, some of the soils do not have sufficient bearing capacity, and the subsurface conditions are "treacherous."²⁶ Soil borings indicate that, in selected areas, substantial bearing capacity is not reached until 35.37 feet below grade. This soil characteristic is found at the river's edge along East River Drive at Boathouse Row. Consequently, most boathouses exhibit similar differential settlement, with the part of the structure near the river subsiding while the part near the Drive remaining in place. To complicate the situation, the building's wooden pilings had failed and were affecting the stability of the structure.²⁷ To address this condition, Mr. Dowd prepared designs for an extensive structural stabilization project in the late 1980s to the early 1990s.

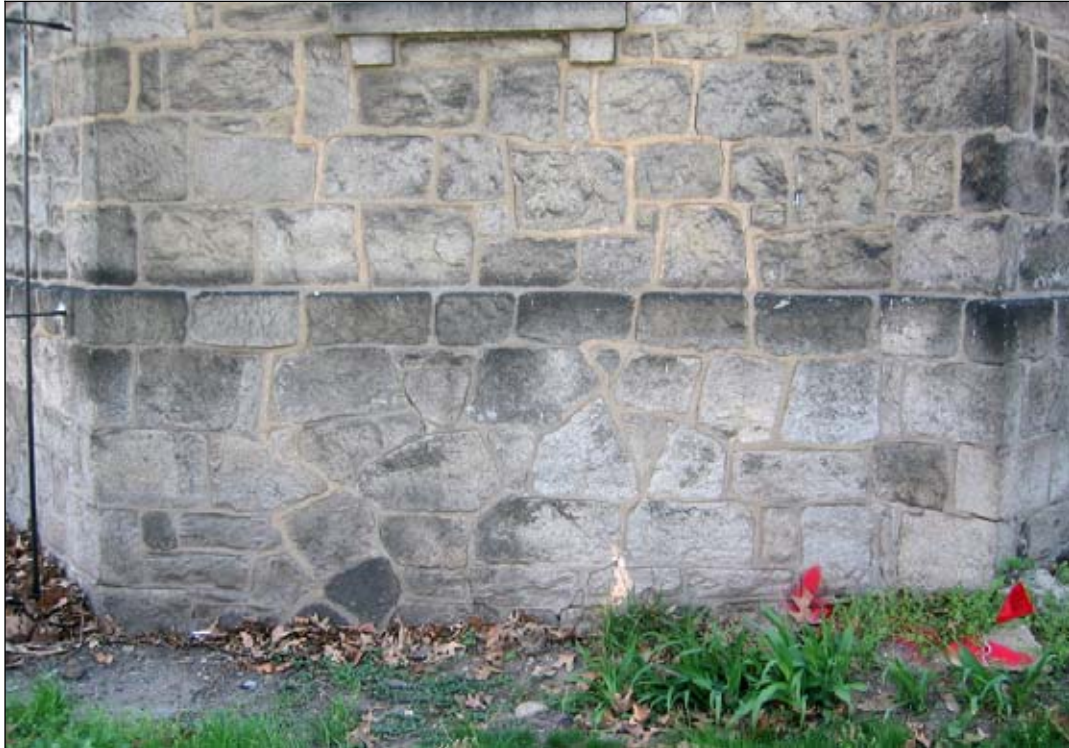
Figure 21: Northwest elevation, detail showing soiled stone, especially along the stone articulation separating the raised basement and first floor and on the building's corners. (Photograph by author, 2005)

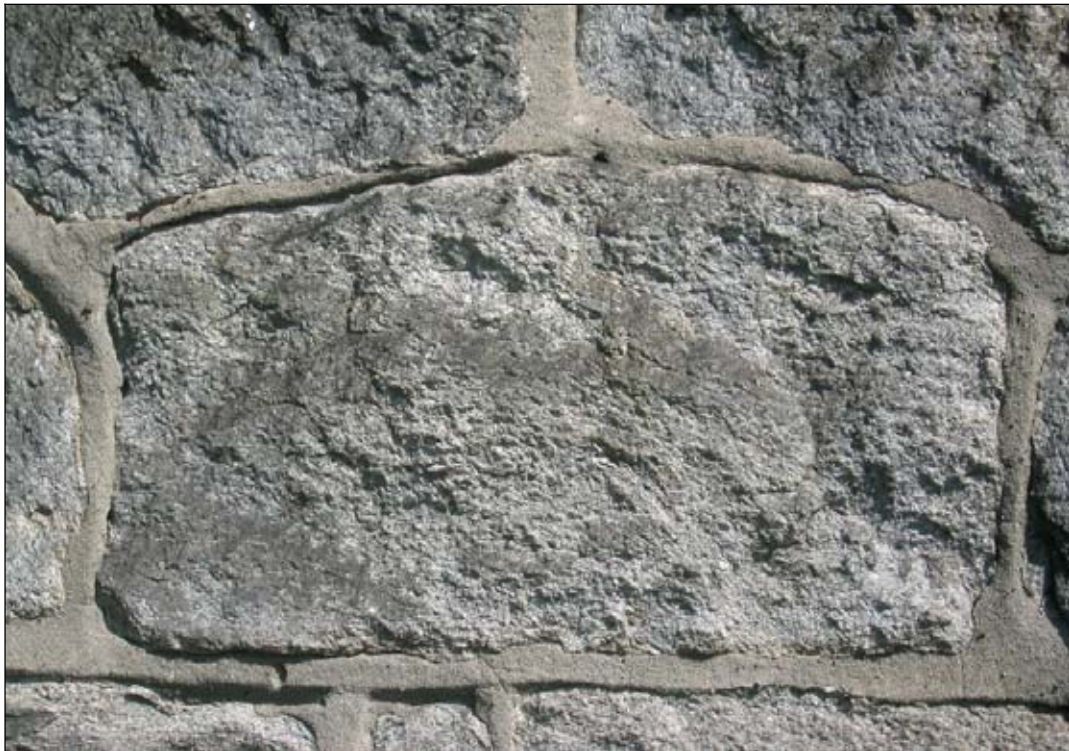
Figure 22: West elevation, detail of building's masonry, coarse-grained and soiled granite. (Photograph by author, 2005)

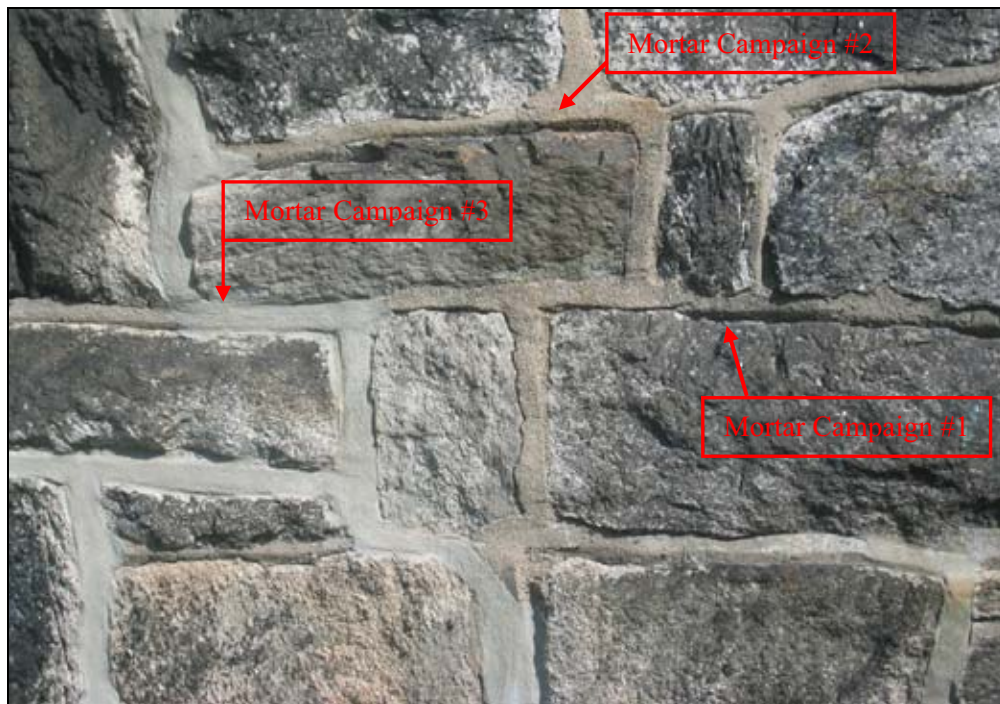
Inspection of the masonry's mortar finds evidence of cracking and missing mortar where the mortar joints and beds have begun to fail. Some of these cracks appear in the mortar between the stone units and are most likely the result of settlement cracks. However, where the mortar has failed, up to an inch of exposed stone is seen in the joints. (Figure 51) This allows moisture to sit in the joints, accelerating the weathering of the stone. The joints have also been tuckpointed in several areas of the building with Portland cement instead of the original lime mortar. However, the new mortar does not match the color or consistency of the original and the various campaigns are obvious and unsightly.¹⁸ As cement is a much harder material than lime, it will weather differently

Figure 23: West elevation, detail. View showing three different mortar campaigns with unmatched mortar and style. (Photograph by author, 2005)

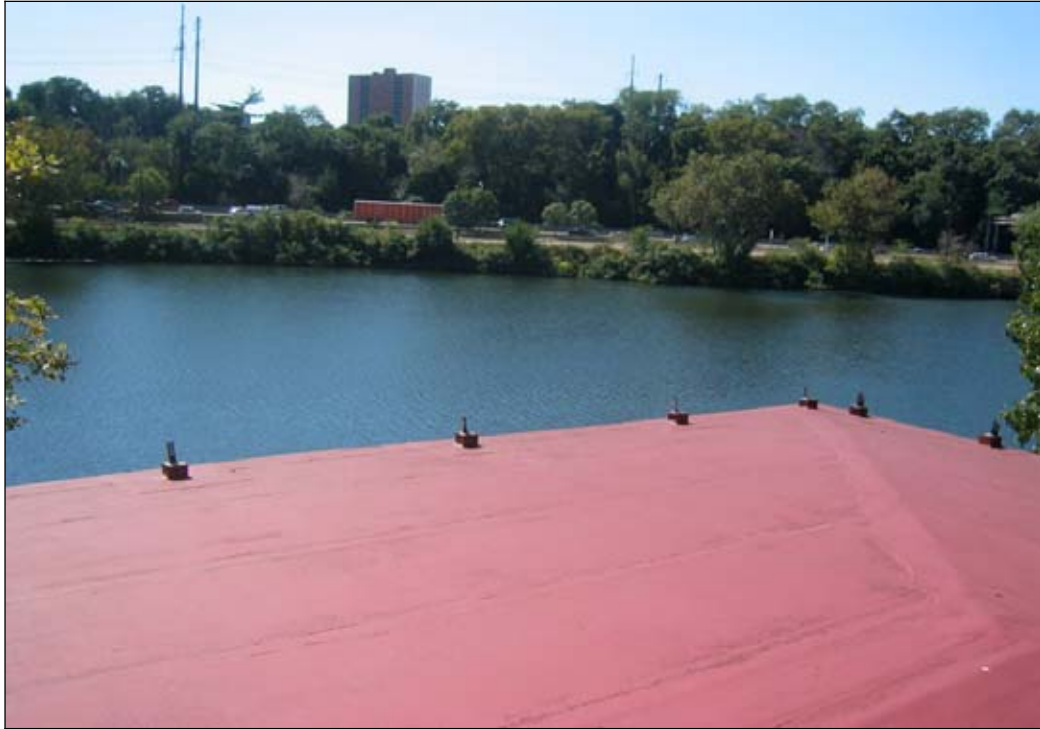
Figure 24: Main roof, looking south towards the Schuylkill River. The shallow surfaces are where water gathers into ponds, thereby increasing the potential for leakage and failure. Evidence of the balustrade appears along the roof edges. (Photograph by author, 2005)

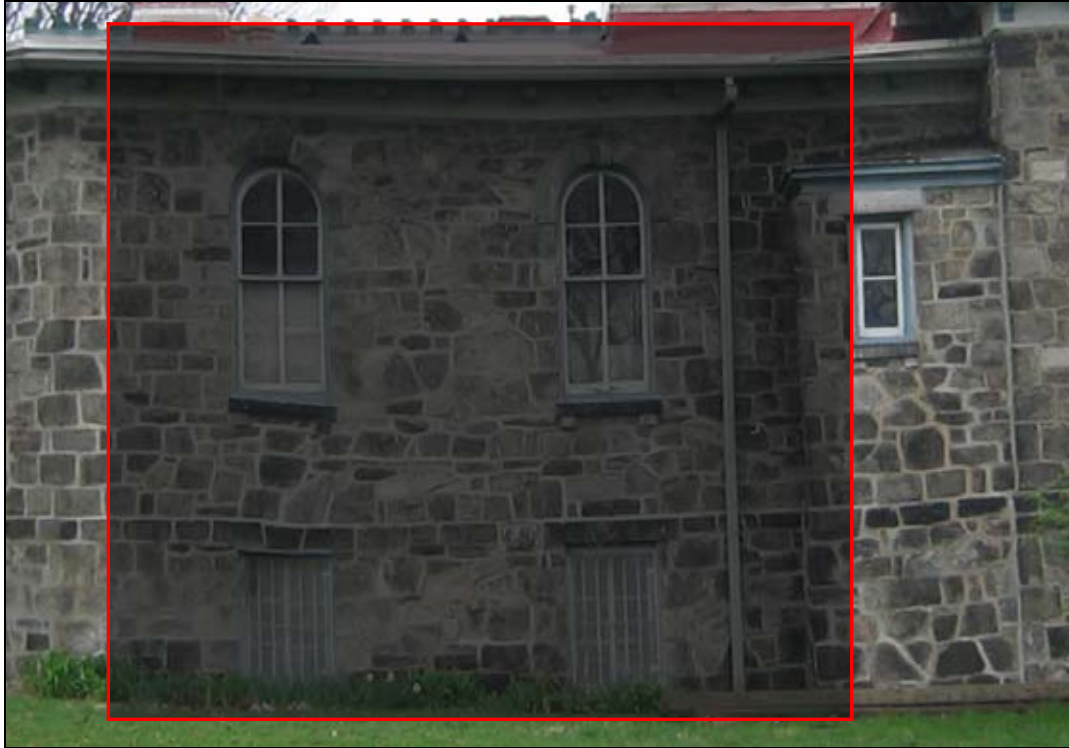
Figure 42: West elevation. View lateral showing wall displacement, especially in the marked area. (Photograph by author, 2005)¹

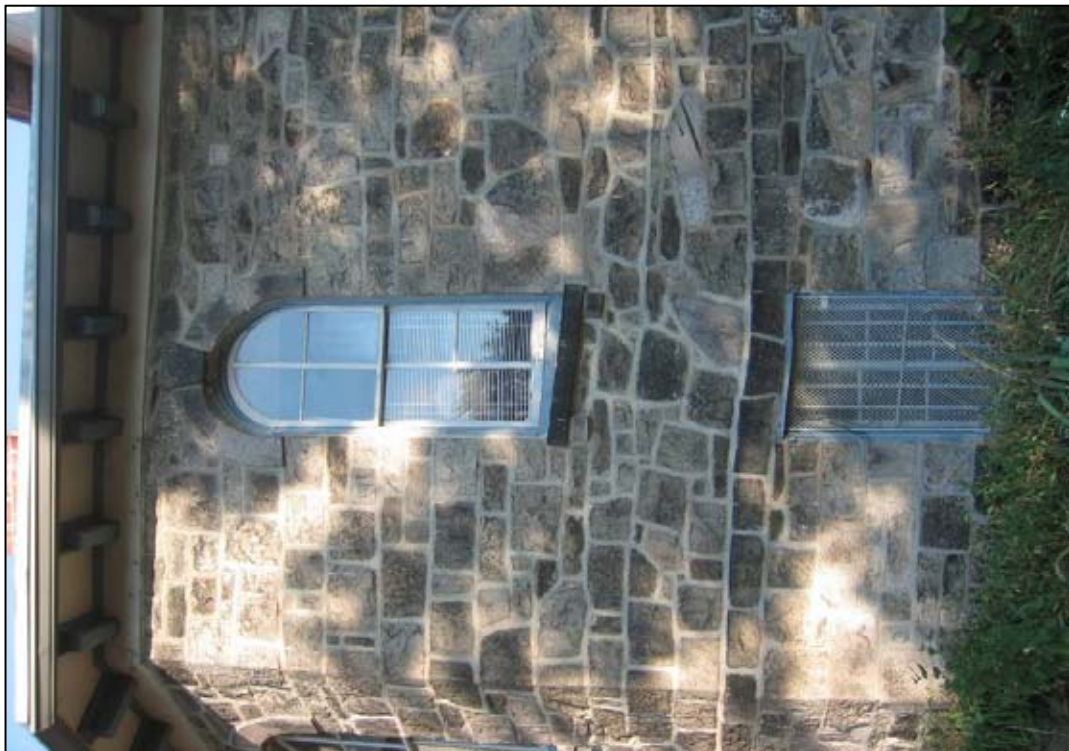
Figure 43: West elevation, detail. View showing window distortion.

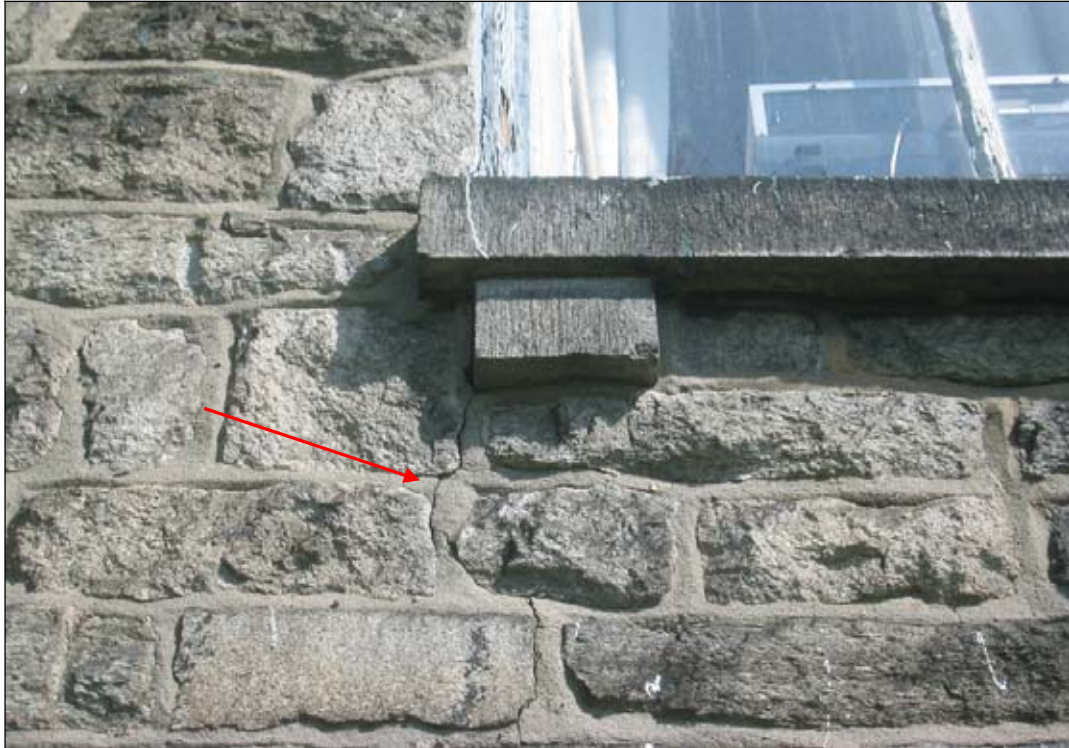
Figure 44: West elevation, detail. Evidence of cracking in mortar beneath window corners.

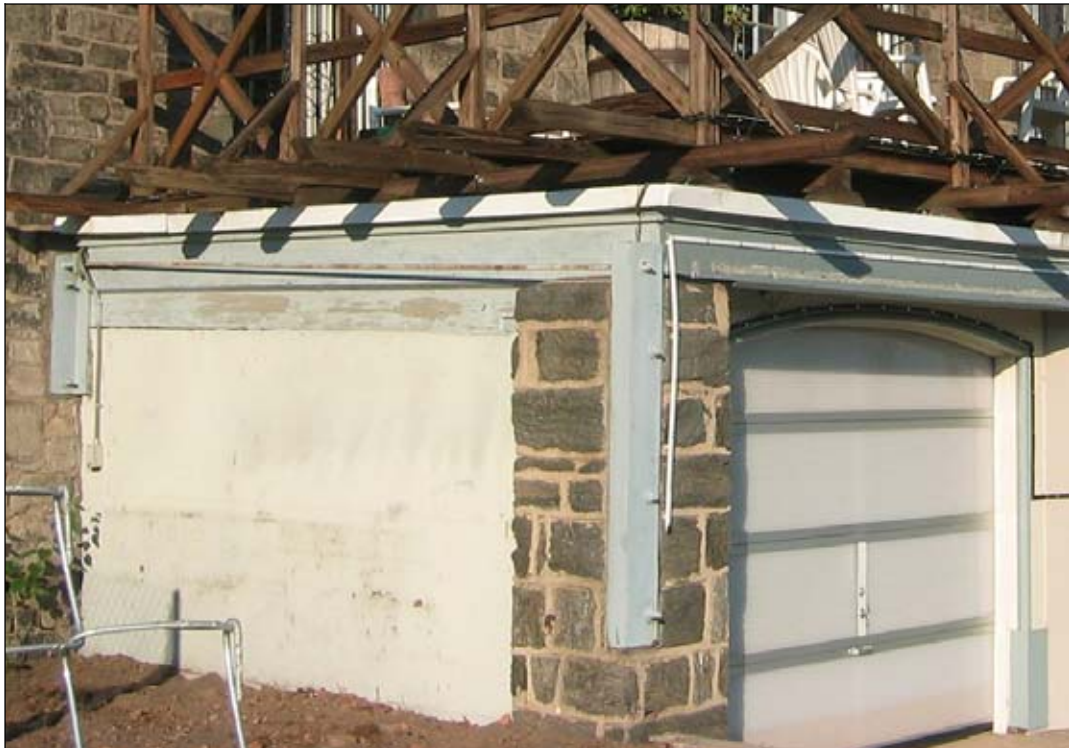
Figure 45: West and south elevations, detail. View showing bracing units on back enclosed porch.

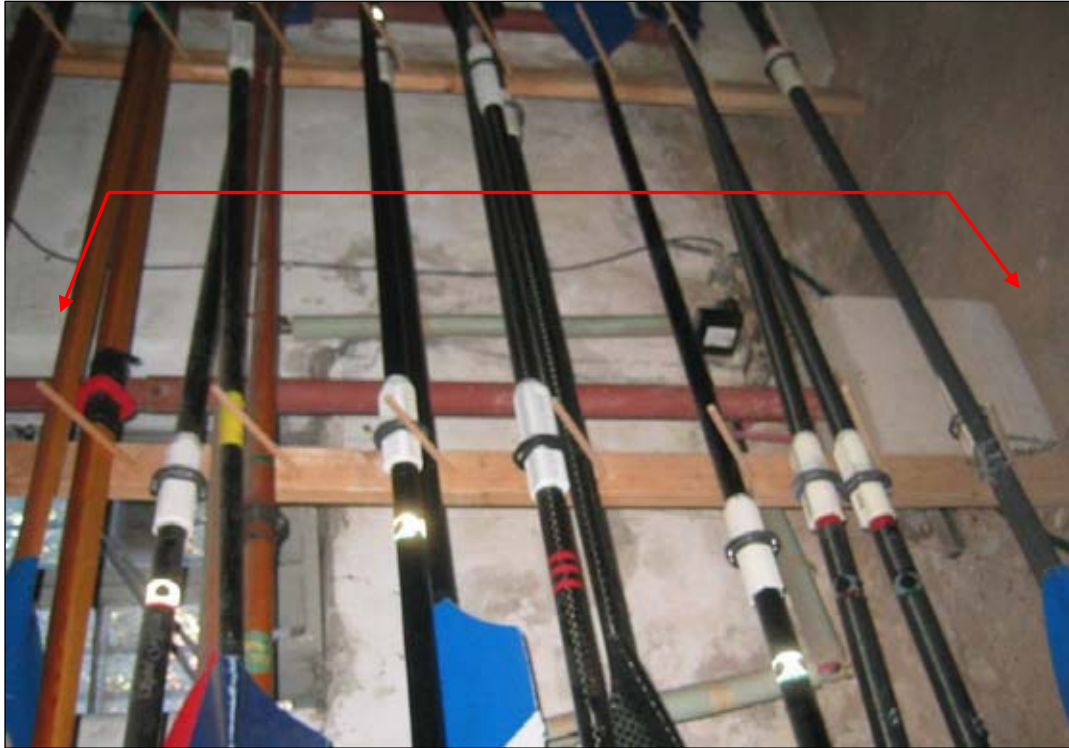
Figure 46: Basement interior, west wall. View showing scaffold jacks holding up wall and floor above.

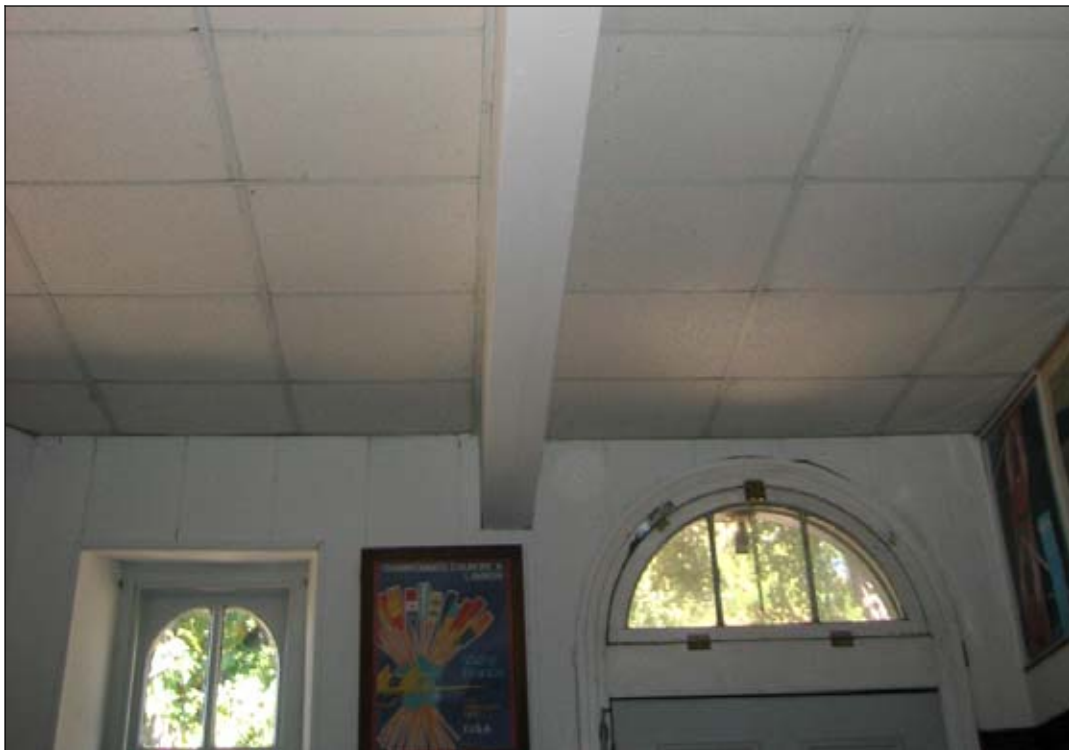
inch to every foot and accelerates in the southwest corner near the kitchen.¹² Although the Club hopes to rebuild the floor in the near future, it does not have the finances to undertake such a job at this time. So, in the meantime, a Club member experienced in construction has installed scaffold jacks in the basement (Figure 46) and behind a false wall in order to provide support and stabilize the floor and wall. In addition, the 1960s removal of one of the interior load-bearing walls, which separated this front room from the central hallway, has also compromised the structural stability of the building's ceiling and roofing system. Although a steel beam was added in 1989 to provide support, along with a suspended ceiling, the area continues to demonstrate structural instability and most likely adds to the floor's slant. (Figure 47)

Figure 47: Front meeting room, north wall. View showing sheathed steel beam where interior load-bearing wall once stood. Photo also depicts suspended ceiling.

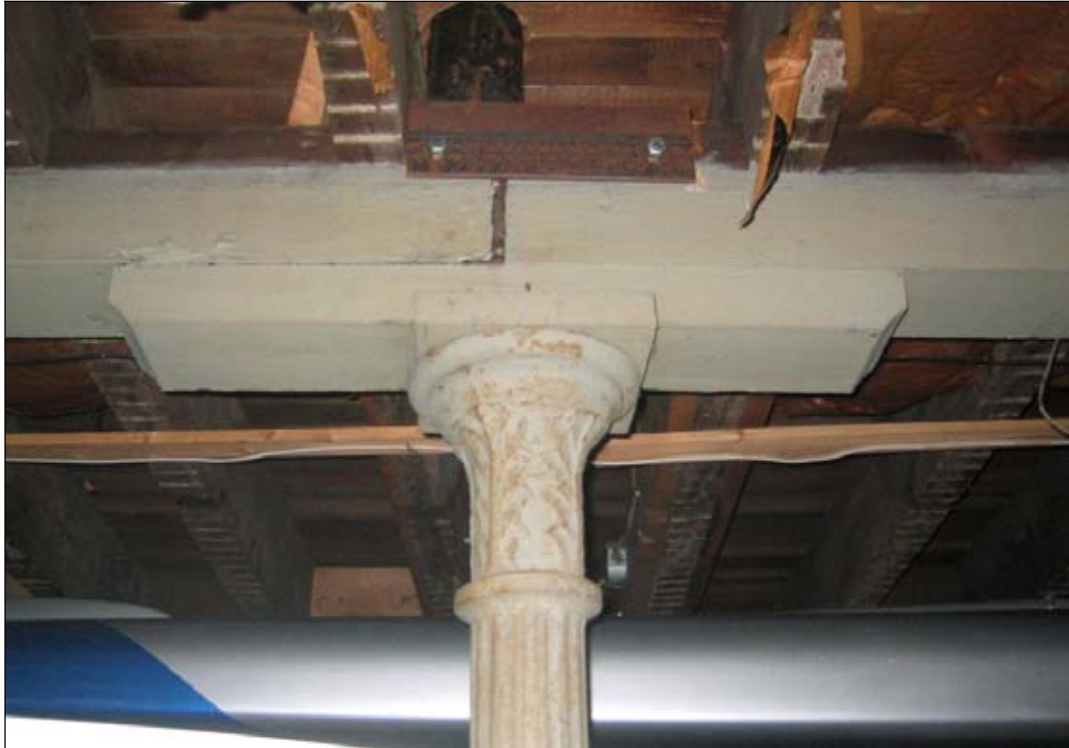
Figure 48: Basement, looking eastwards. View of cast iron fluted column and ceiling joist. Wood shows signs of rotting deterioration.

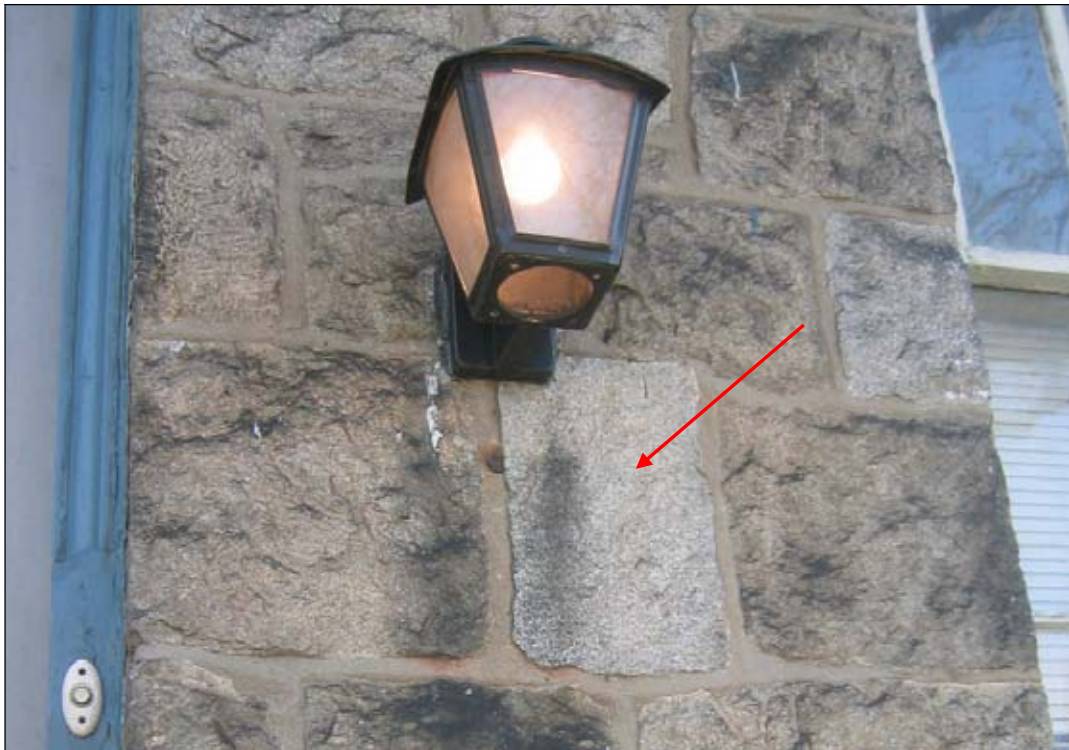
Figure 49: North elevation, detail. View shows staining of stone underneath the iron lamp, most likely due to the metal's chemical reaction with water from rainfall.

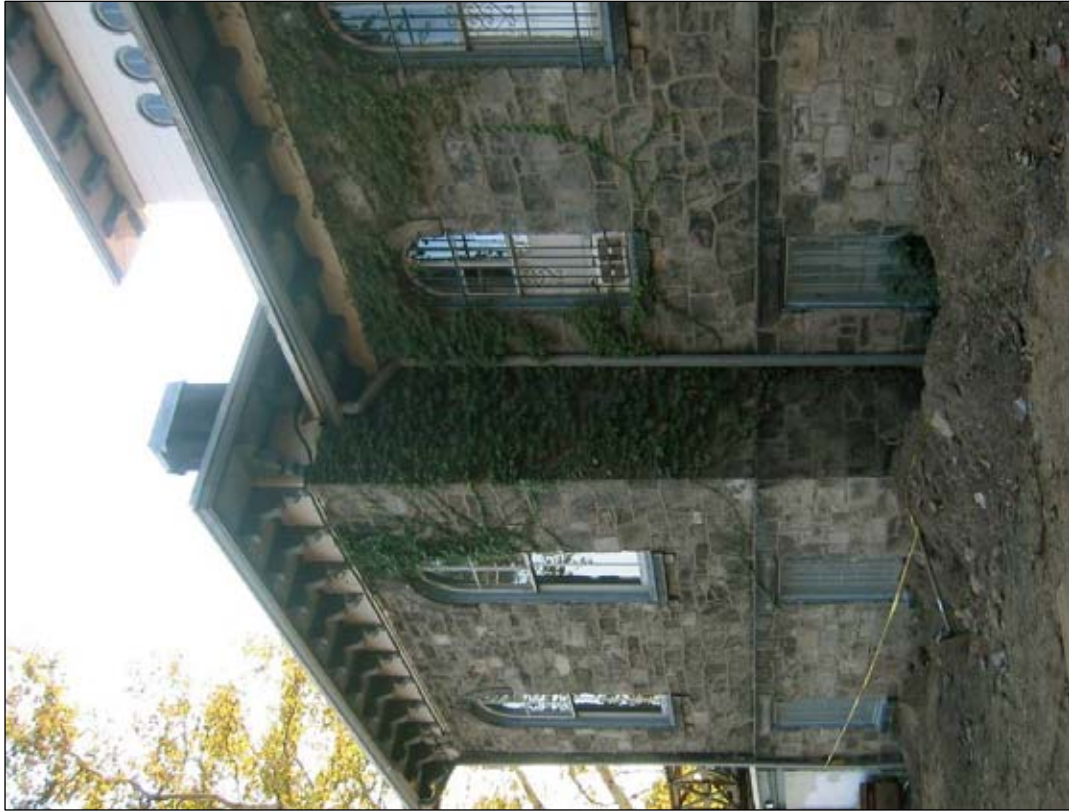
Figure 50: East elevation, looking south towards the river. View shows vegetation in the form of ivy on the wall surface.

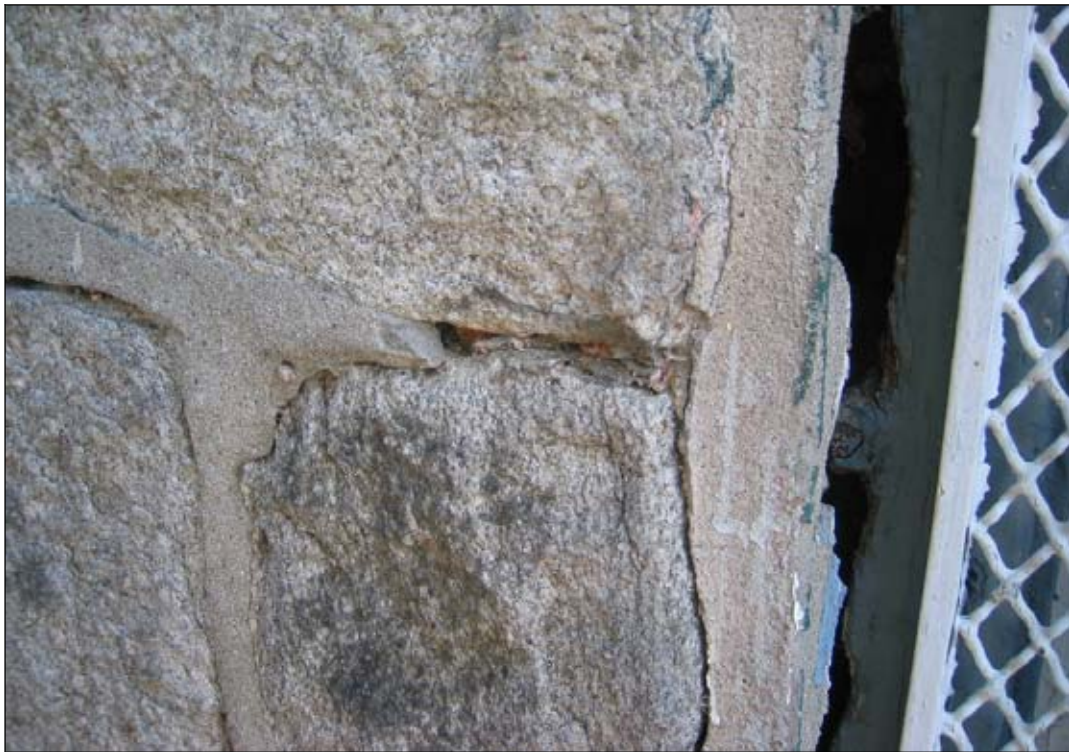
Figure 51: West elevation, detail. Loose and missing mortar from around rough window opening.

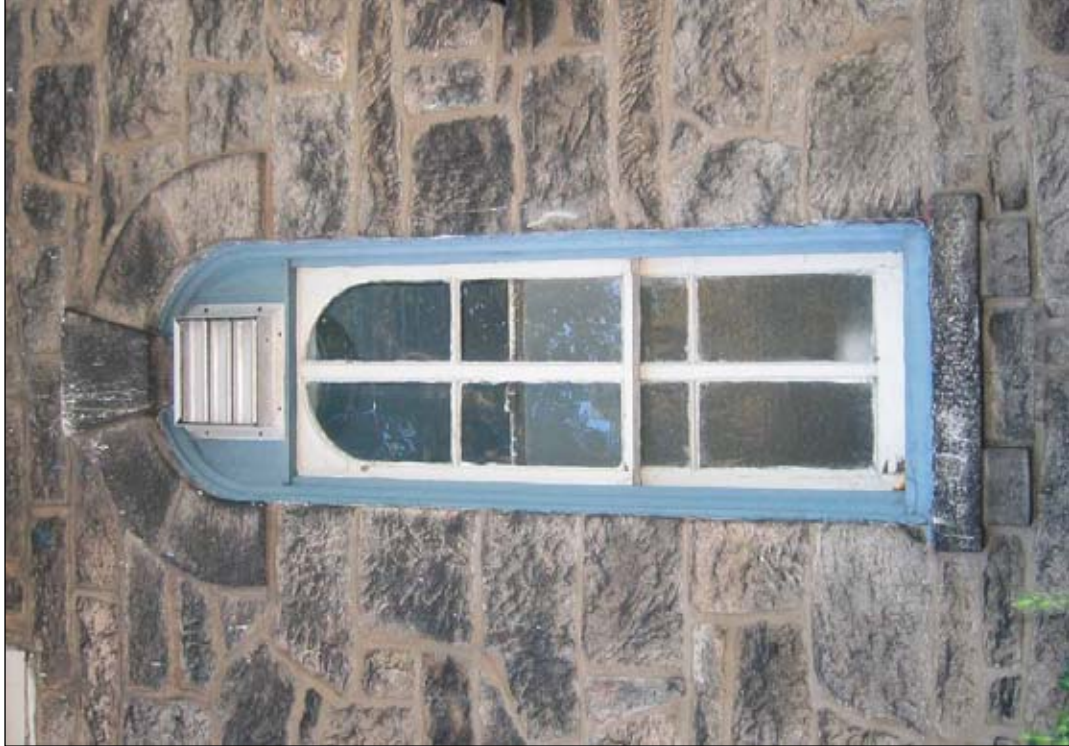
Figure 52: North elevation. Detail of window with addition of metal exhaust fan. Stone surface soiling is also visible, especially on the keystone arch and sill.

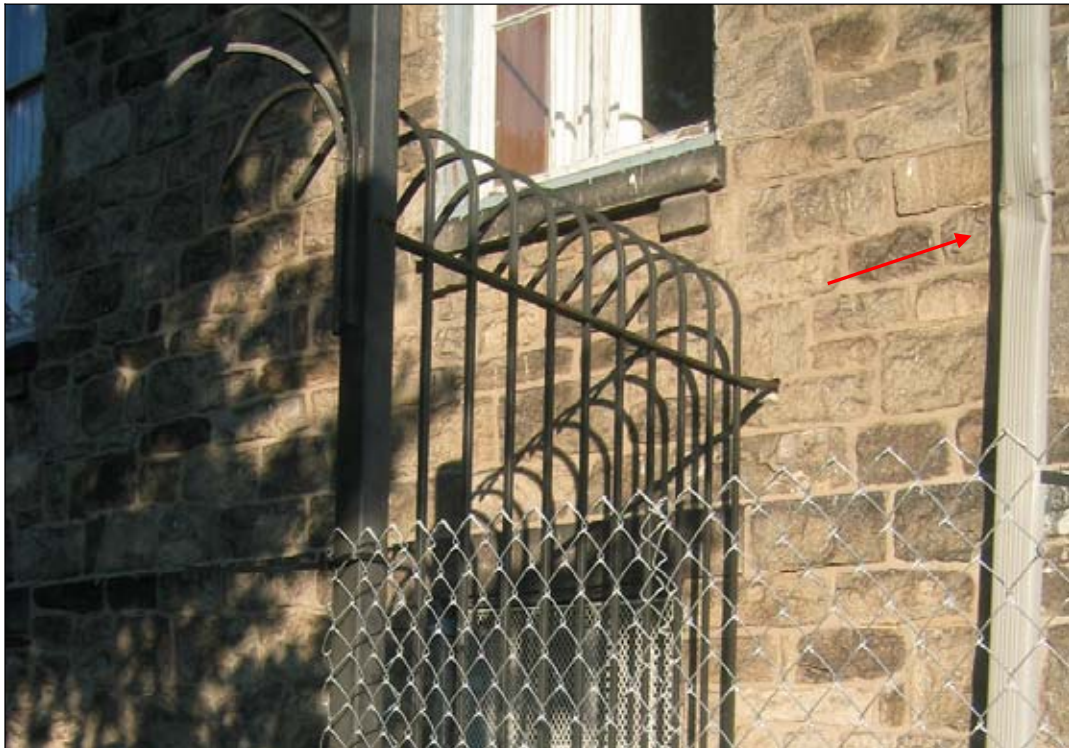
Figure 53: West elevation. Detail shows crushed aluminum downspout which may impede water flow during heavy downpours.

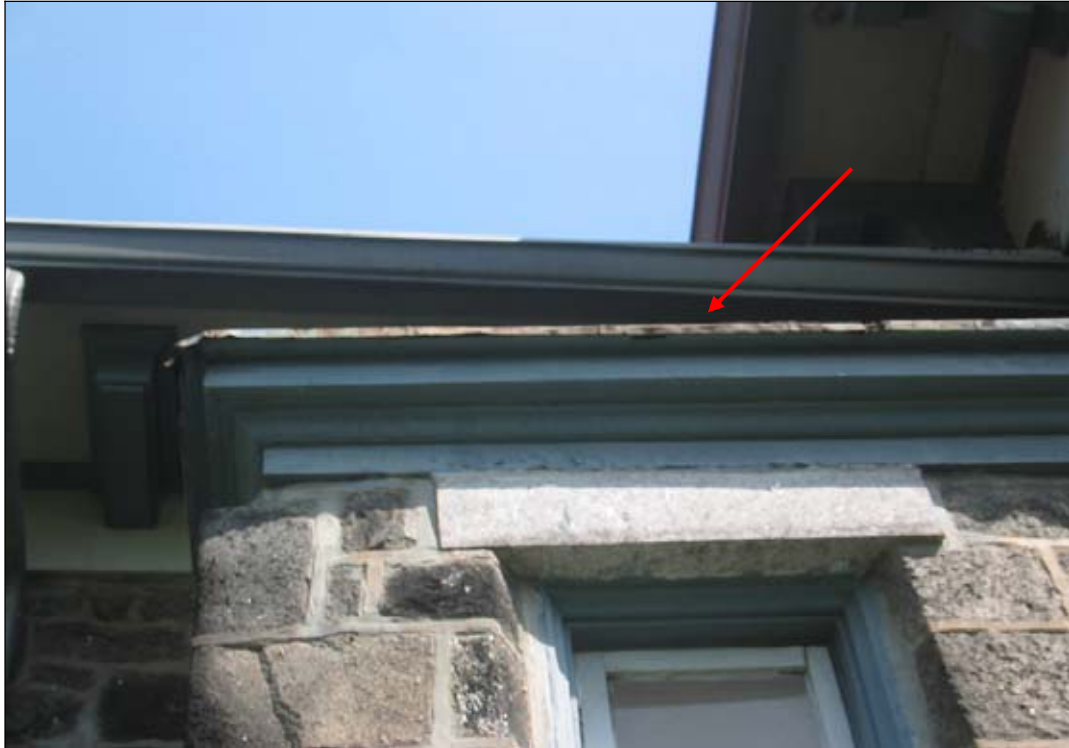
Figure 54: West Elevation, detail of roof. View shows rusting flashing along edge.

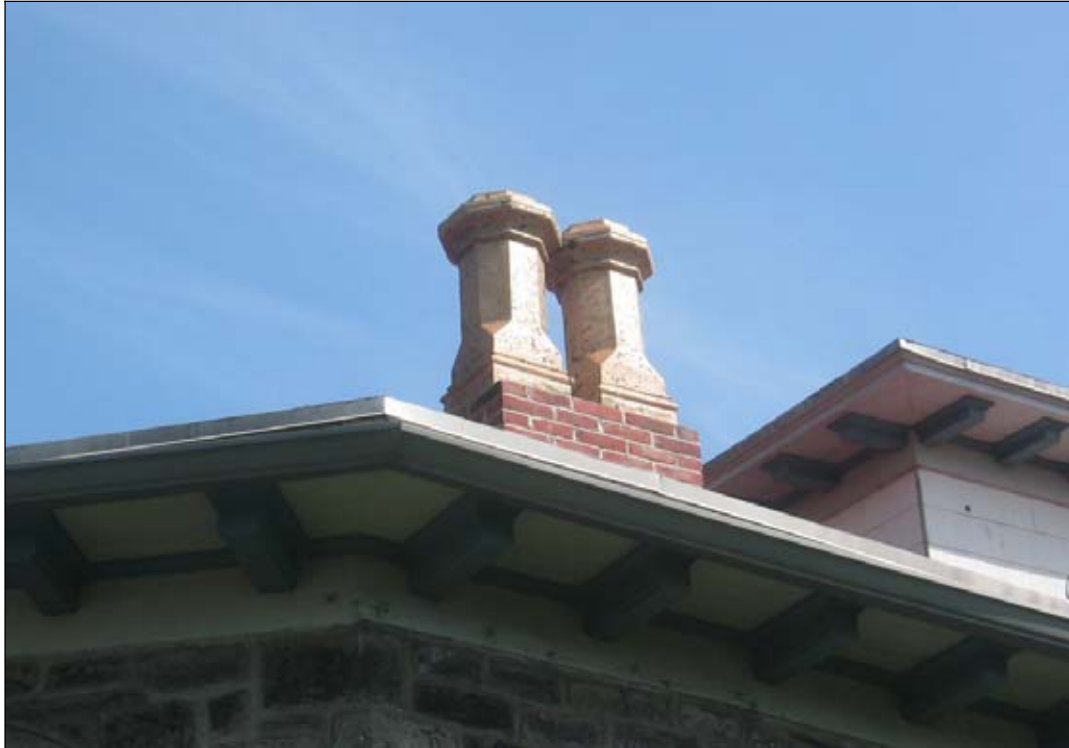
Figure 56: West elevation, detail of roof. View shows flaking paint on terra cotta chimney stacks.

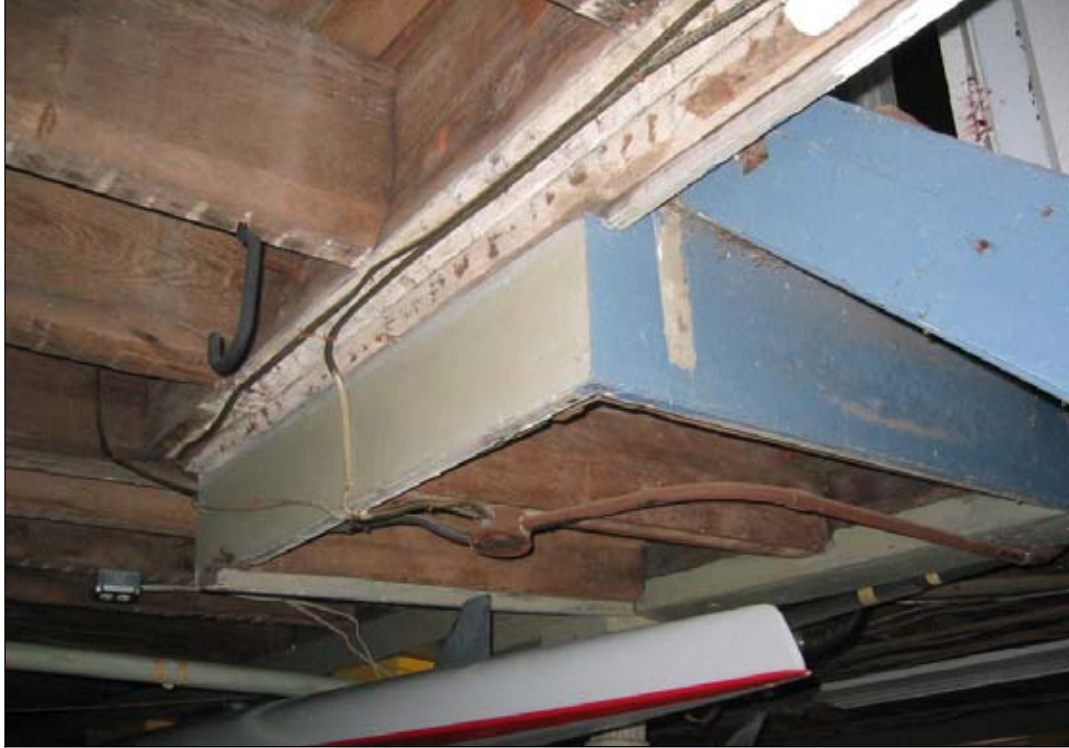
Figure 60: Basement, ceiling detail beneath stair opening. View shows remnants of old electrical wiring, along with newer additions.

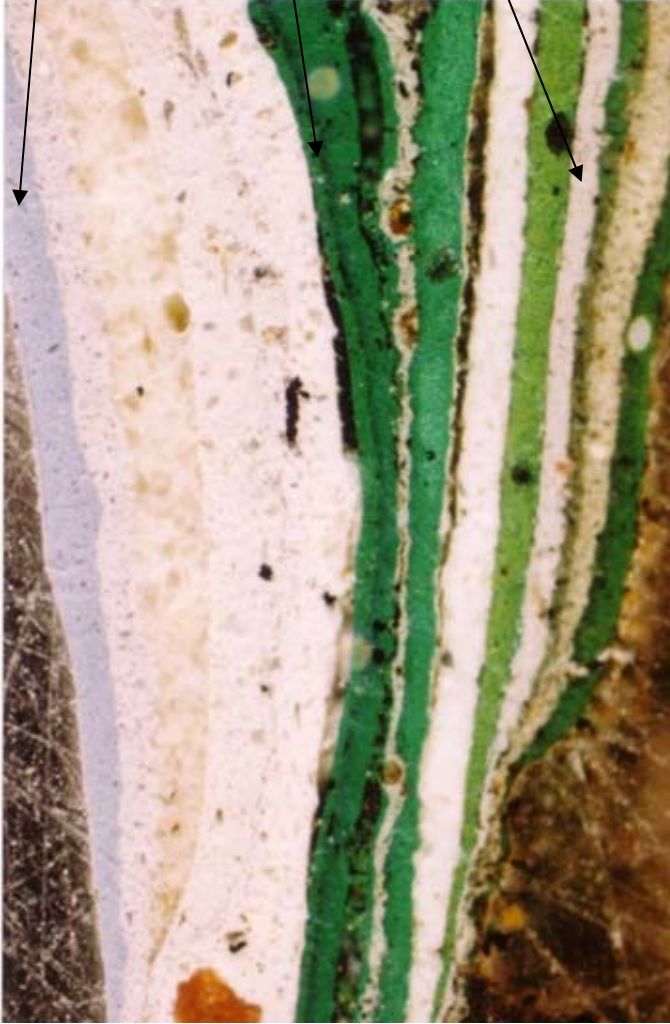
<p>16) light blue-grey</p> <p>15) white</p> <p>14) white – more cream</p> <p>13) white</p> <p>12) white</p> <p>11) dark green</p> <p>10) dirt layer</p> <p>9) dark green</p> <p>8) white</p> <p>7) dark green</p> <p>6) white</p> <p>5) bright green</p> <p>4) white</p> <p>3) dark green</p> <p>2) off white</p> <p>1) dark green</p> <p><i>Comments:</i> The horizontal voids indicate weak paint layers separating from each other.</p>

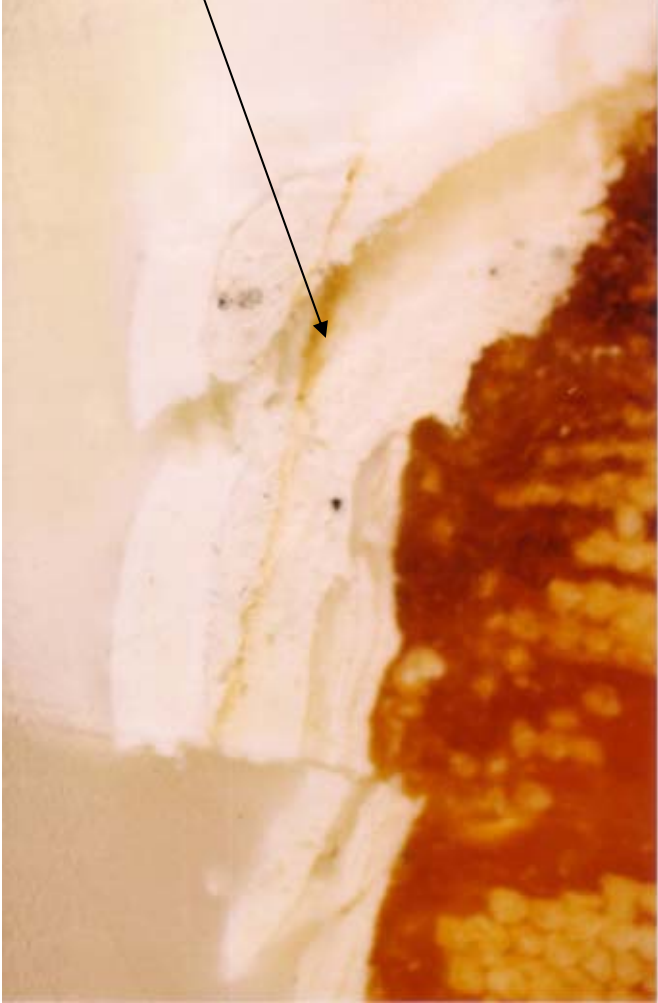
<p>7) white</p> <p>6) white</p> <p>5) white</p> <p>4) dirt layer</p> <p>3) white</p> <p>2) white</p> <p>1) substrate</p> <p><i>Comments:</i> The photograph shows evidence of paint flaking.</p>
