The Philadelphia Girls' Rowing Club: An
Incremental Historic Structure Report

**THE PHILADELPHIA GIRLS' ROWING CLUB:
AN INCREMENTAL HISTORIC STRUCTURE REPORT**

Anna Stillner

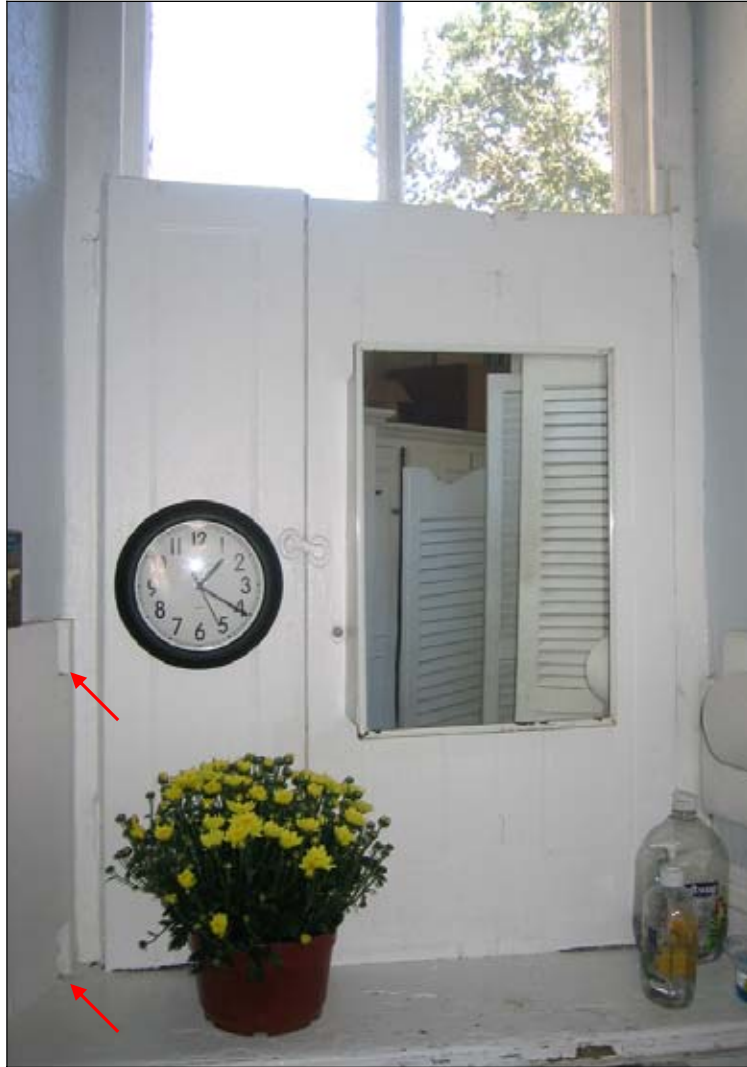
Figure 19: Shower/Bathroom, north wall. Detail of historic interior shutters. Arrows point to the notches where bars were slipped into place for security purposes. (Photograph by author, 2005)

thereby locking the shutters closed. *[See also Figure 26 in Chapter 5 for another photo of the wooden, security piece.]* Since this system would have been used for security purposes, it is most likely that all the windows on the first floor, of similar size, would have had shutters. Unfortunately, the modern plywood paneling on the walls in the

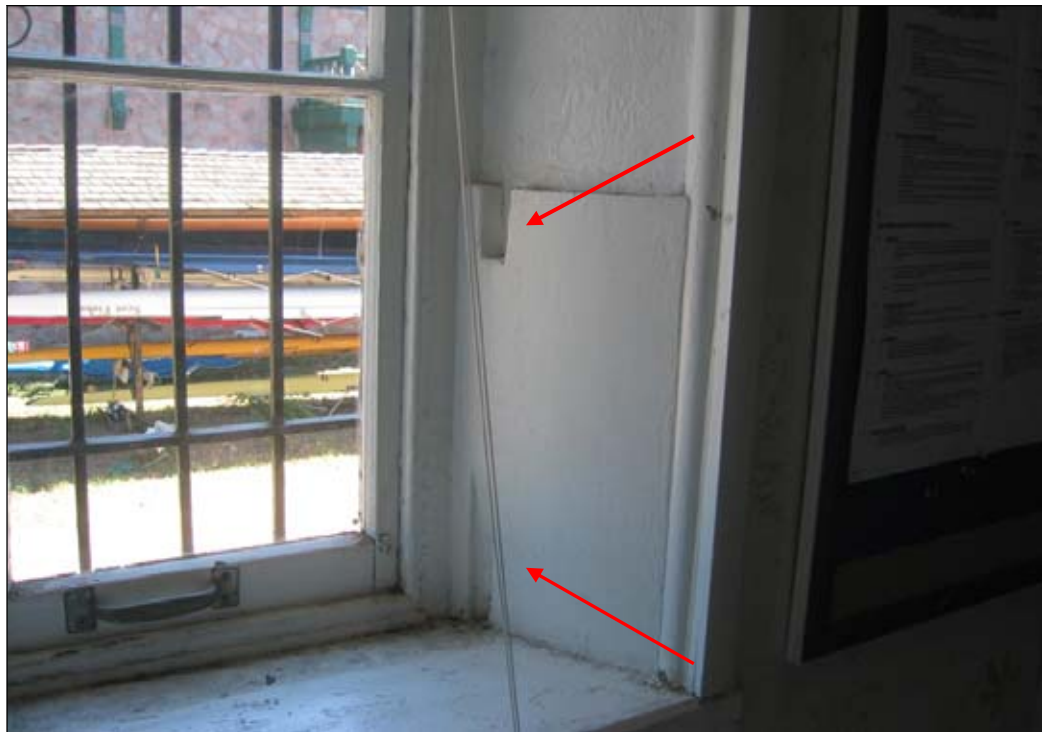
Figure 26: Locker room, east wall. Detail shows trace of shutter protection system. (Photograph by author, 2005)

remains in the form of the notched wooden pieces on either side of the window. Used to hold security bars in place over the shutters, they would have prevented the shutters from being pushed inwards. Some time after 1975, iron fences were installed to block off the west side of the property near the water and to protect the boathouse storage space,

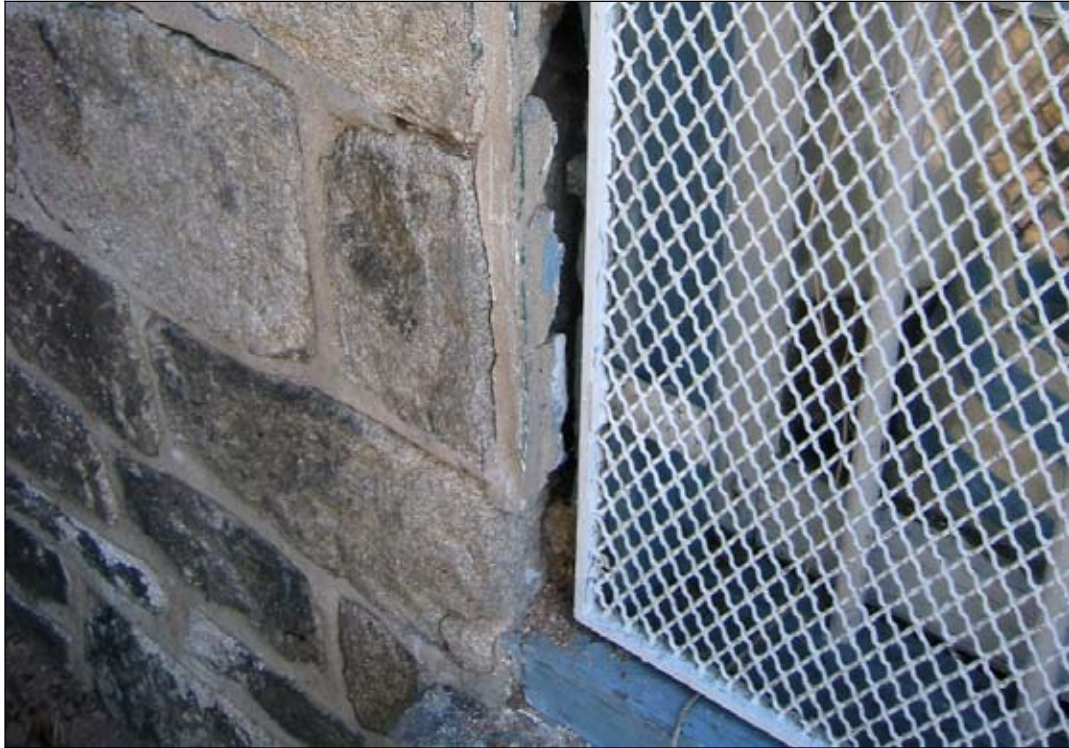
⁷ Specifically, the sample was taken from mortar surrounding the far right basement window on the west elevation.

Figure 27: West elevation, detail of basement window where the mortar sample was taken. (Photograph by author, 2005)

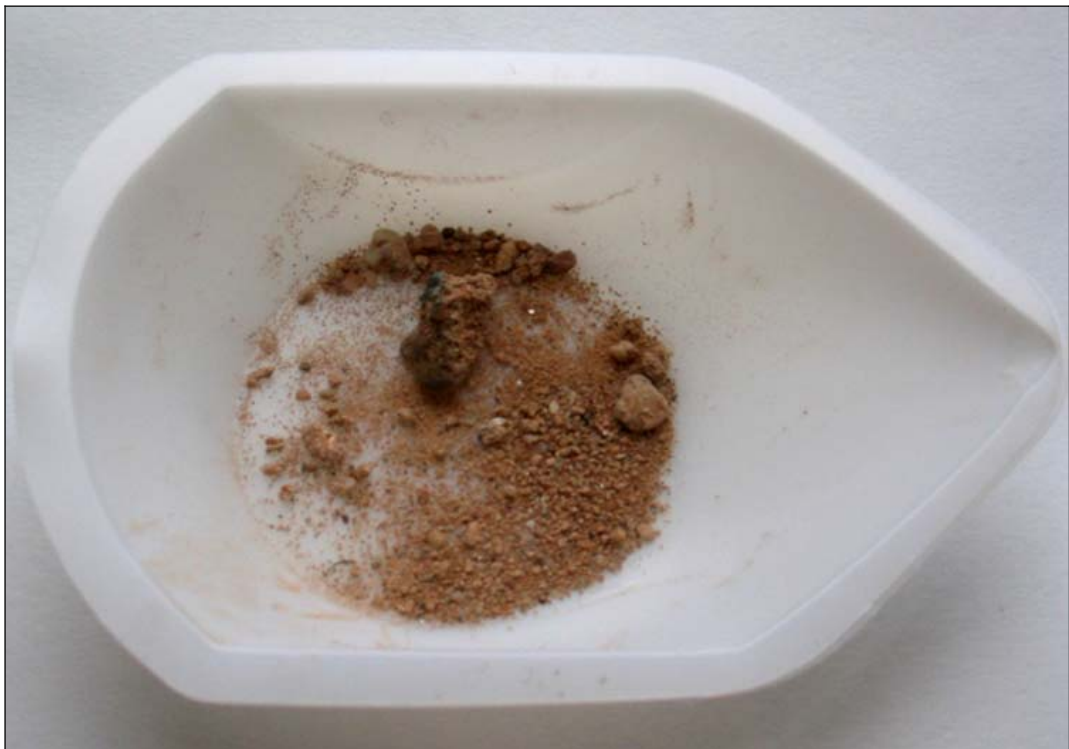
Figure 28: Detail of mortar sample before lab analysis. (Photograph by author, 2005)

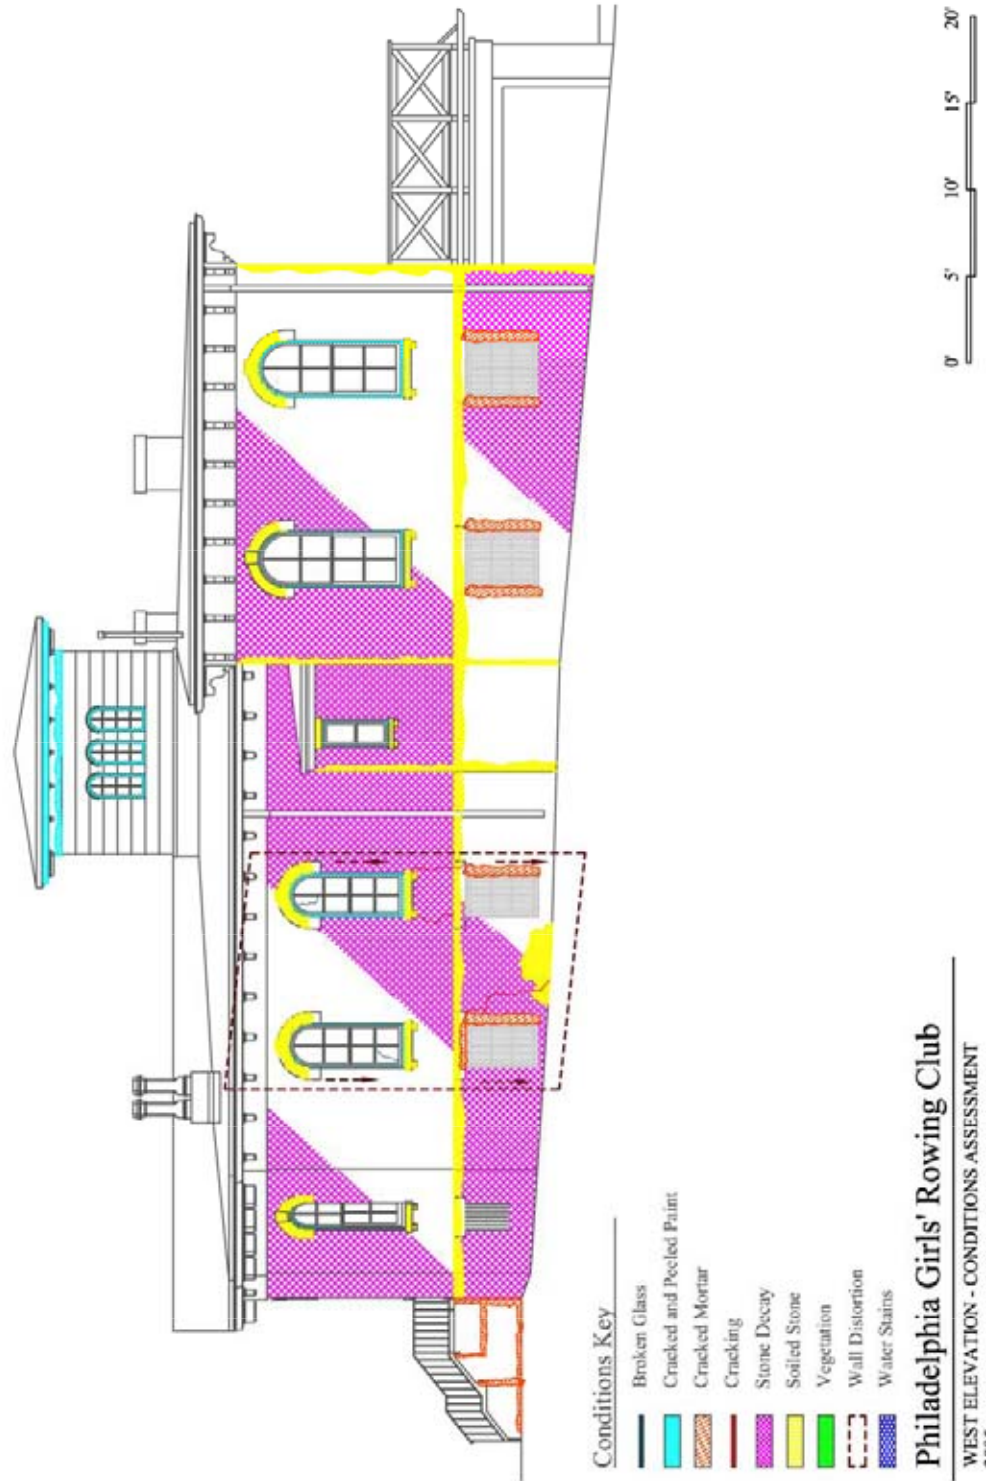
Drawing 10: West Elevation, Conditions Assessment (AutoCAD drawing by author, 2005)

Overall, the structural system of the building is compromised due to differential settlement and foundation failure. Occurring primarily in the front portion of the west wall, this localized foundation failure reflects itself in the distorted appearance of the wall. The displacement not only affects the masonry and mortar, but also the window openings and window units themselves. Several of the glass panes in the two windows over this failure are broken, most likely from this movement over the years. In addition, large cracks run from the corners diagonally downwards from these same windows. Cracking is frequently associated with structural movement patterns, so it comes as no surprise that they exist in this location. *[Please see Drawing 10 on the next page, as well as Figure 44 in Appendix D.]*

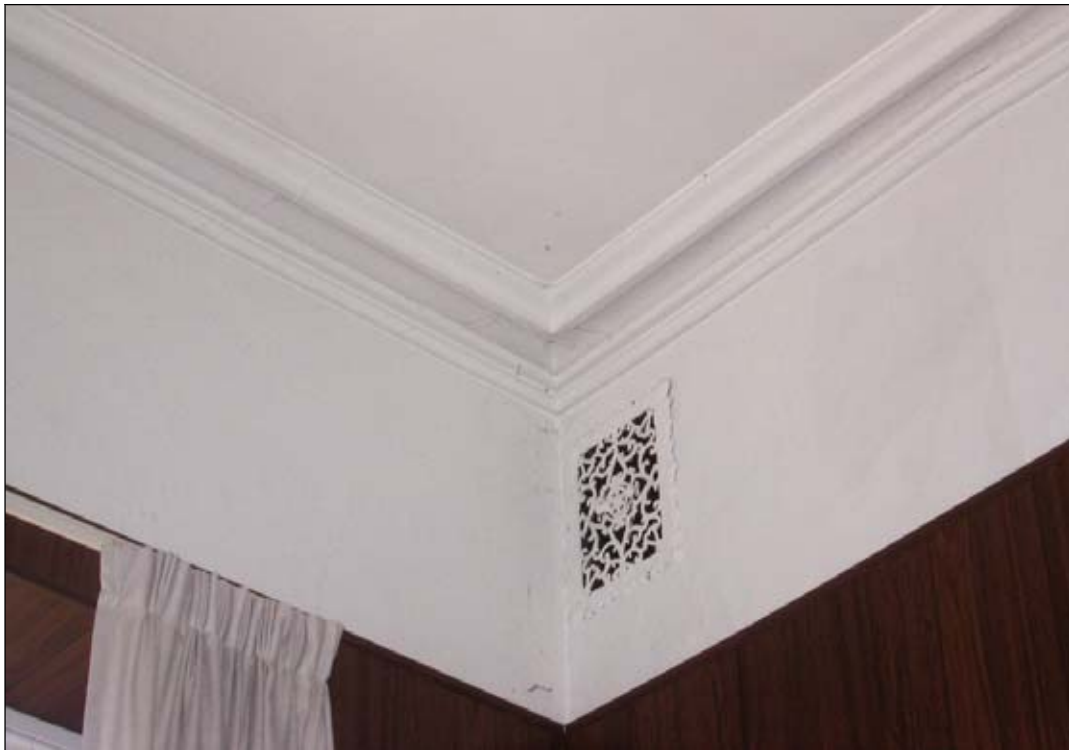
The Philadelphia Girls' Rowing Club's heating system is provided by a forced, hot air heater located in the stairs to the cupola. Three ceiling diffusers and one wall grille for the shower room are used to distribute the heat throughout the building. (Figure 55) Historically, heating would have also been provided by the wood-burning fireplaces, especially the large limestone one in the back riverfront room. Still working, this back fireplace is used occasionally in the winter months.²⁴ A 1911 fire insurance survey indicates that the building was heated by gas stoves. The terra cotta chimney stacks that stand on the front portion of the roof would correspond to this heating method. Inspection of their surface shows evidence of paint peeling, which leaves the terra cotta vulnerable to water damage. (Figure 56) In addition, a 1938 fire insurance survey of the property makes note that the building was formerly heated by a hot air furnace located in

Figure 55: South meeting room. Detail shows ceiling wall diffuser.

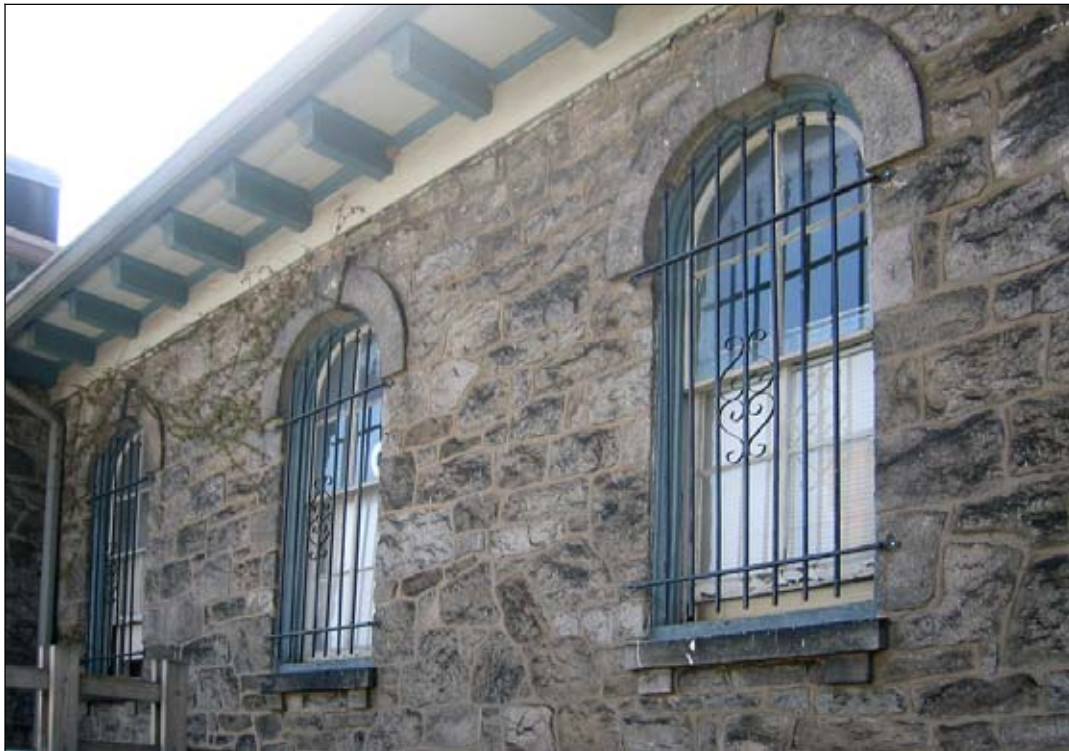
Figure 57: East elevation, detail. View shows iron rod grilles over window openings.

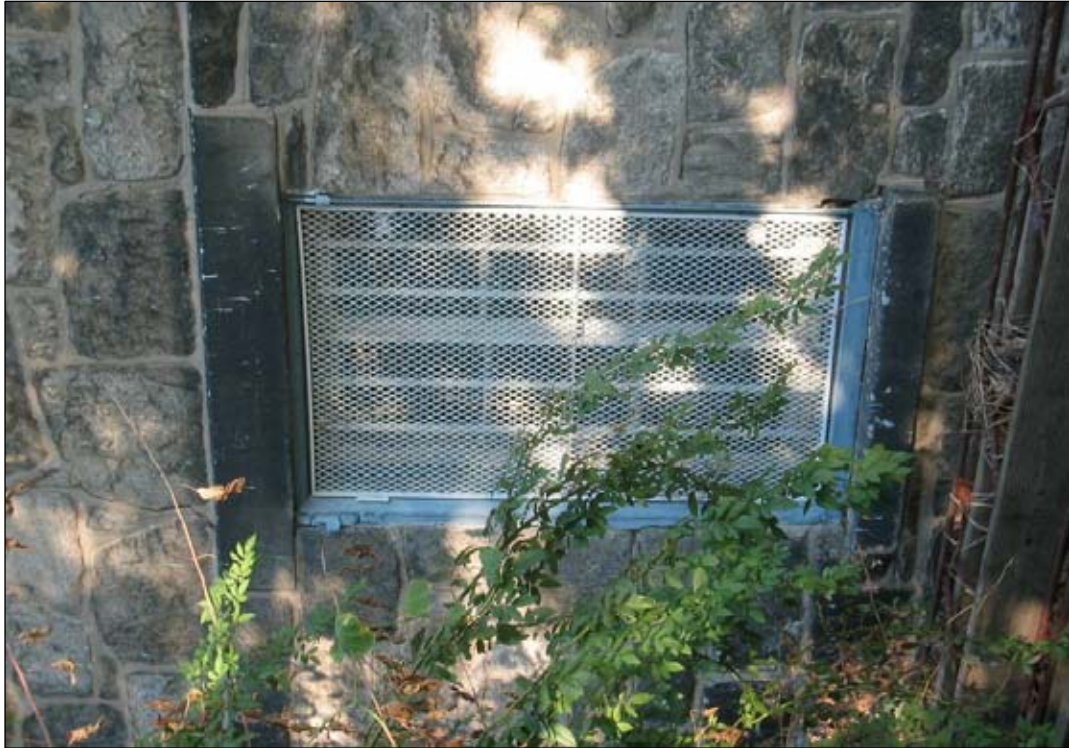
Figure 58: West elevation, detail. View show metal rods and grille over basement window opening.

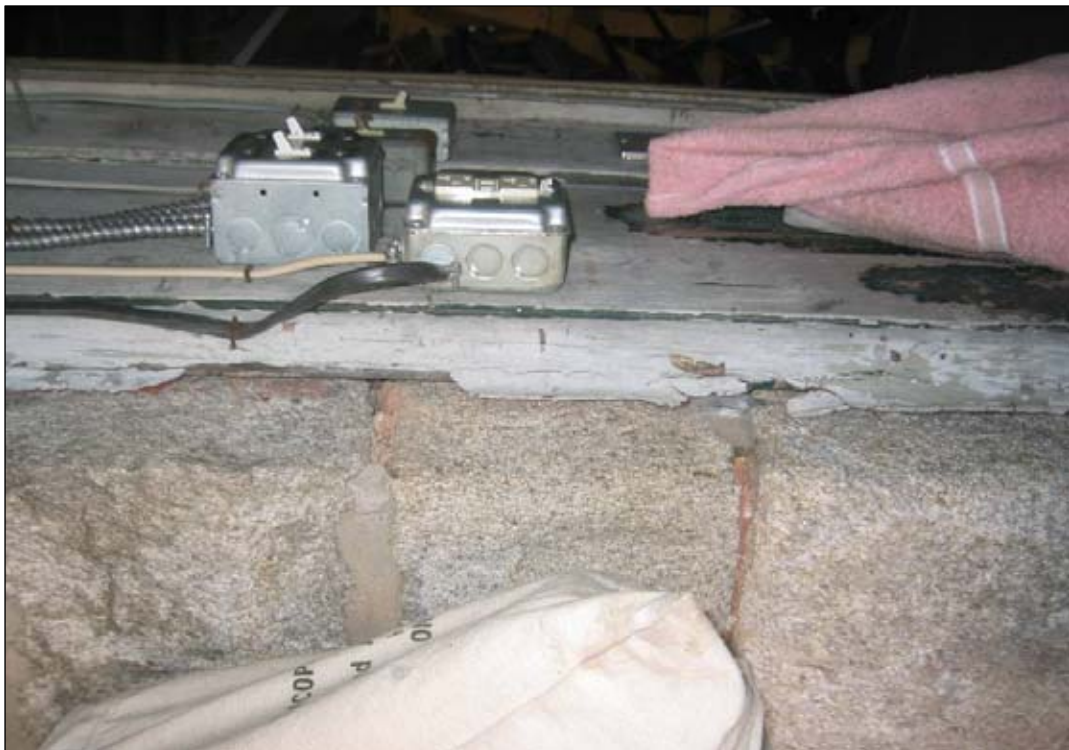
Figure 59: Basement, beside back bay door. Detail shows examples of modern light switches and power outlets.

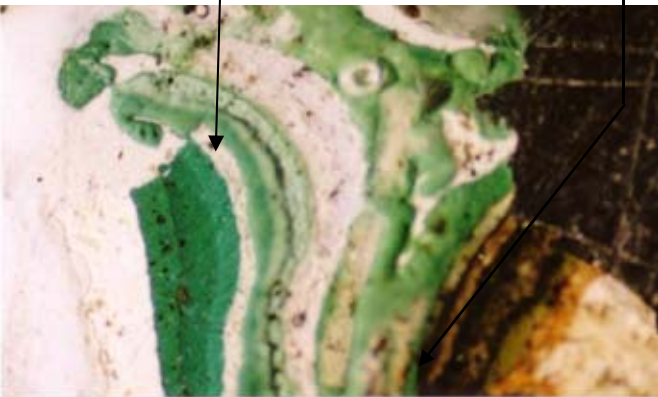
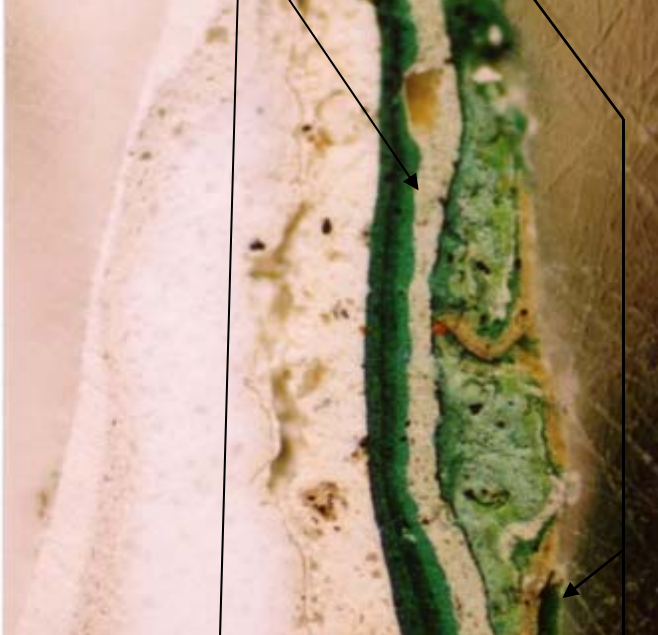
- 13) white
- 12) white
- 11) dark green
- 10) dark green
- 9) bright green
- 8) white
- 7) bright green
- 6) light green
- 5) white
- 4) dark green
- 3) light tan
- 2) green
- 1) off white (primer)

Comments: Since swirling occurs in the bottom layers, due to paint build-up near the crown molding, two photographs were included for better accuracy.

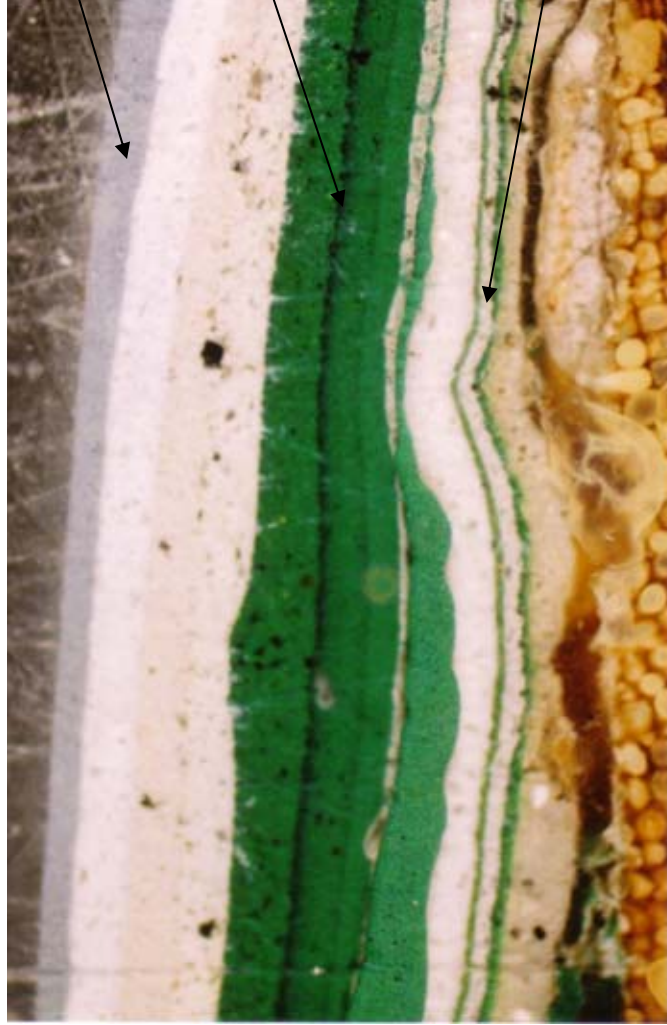
- 16) light blue-grey
- 15) white
- 14) white
- 13) white
- 12) dark green
- 11) dirt layer
- 10) dark green
- 9) dark green
- 8) white
- 7) dark green
- 6) white
- 5) dark green
- 4) white
- 3) dark green
- 2) off white (primer)
- 1) substrate

Comments: The substrate is separating from the first paint layers.

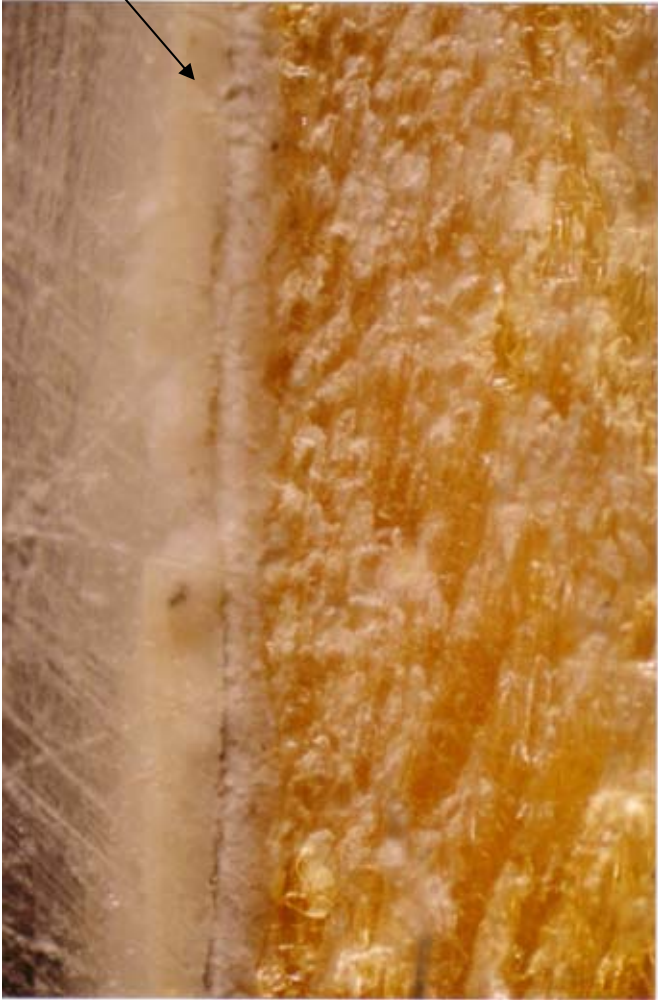
<p style="text-align: center;"> 3) white 2) white 1) substrate </p> <p><i>Comments:</i> This sample demonstrates the bottom two paint layers only.</p>

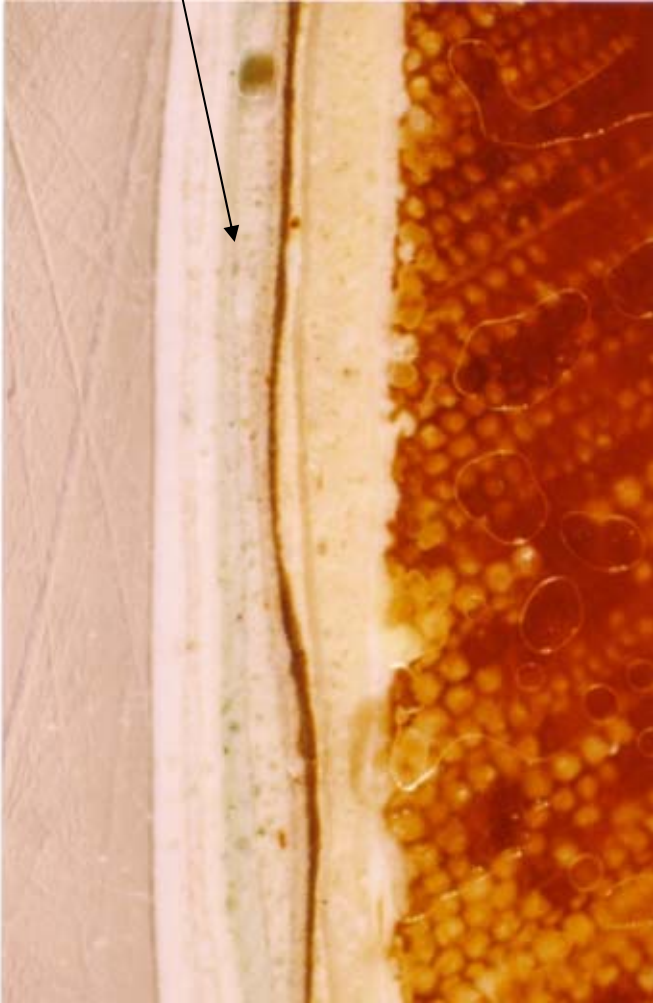
<ul style="list-style-type: none"> 11) white 10) white 9) white 8) white – gray 7) white 6) off white 5) dark brown 4) off white 3) off white 2) off white (primer) 1) substrate 	
<p><i>Comments:</i> Water bubbles caught beneath the cover slide may be seen on the substrate layer. In addition, Layer #8's dark brown color may be due to a separation in the paint layers - not a new layer.</p>

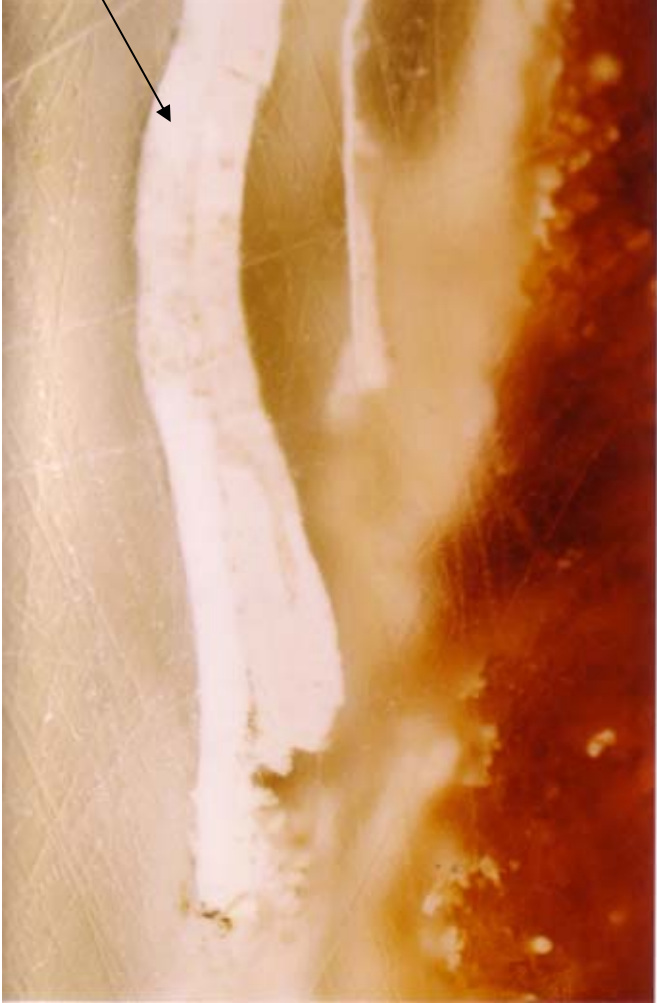
<p>3) white</p> <p>2) white (primer)</p> <p>1) substrate</p> <p><i>Comments:</i> The voids indicate paint layers separating from the substrate.</p>

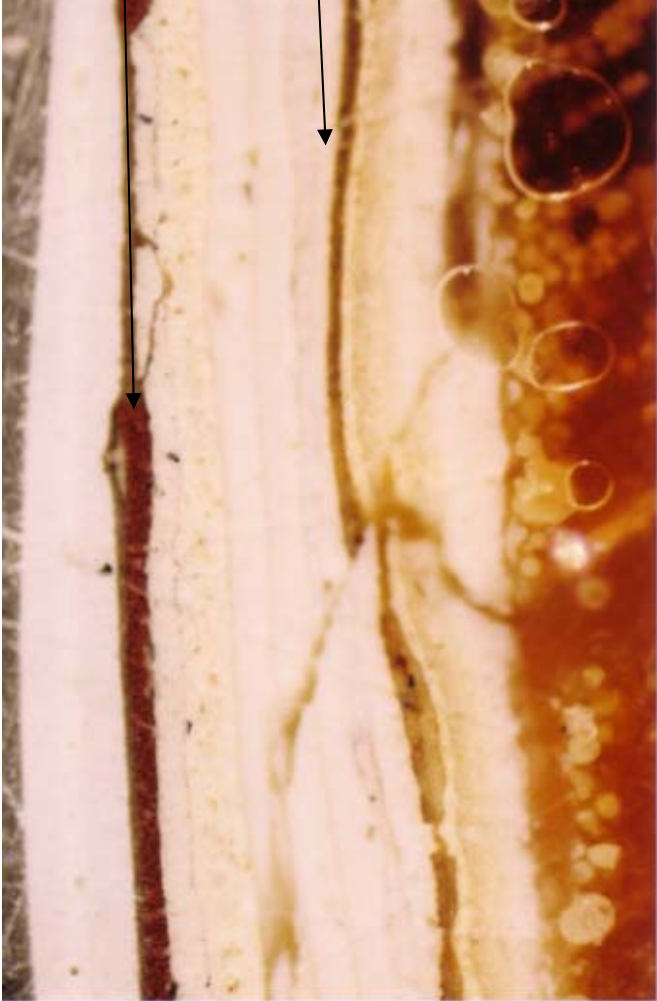
<ul style="list-style-type: none"> 12) white 11) white 10) white 9) dark brown-red 8) white 7) off white 6) white 5) white 4) white 3) off white 2) off white (primer) 1) substrate 	
<p><i>Comments:</i> Cracking of the paint layers is seen, as well as and water bubbles caught beneath the cover slide. The brown, horizontal line below Layer #4 is interpreted as a separation of paint layers, rather than a separate layer.</p>

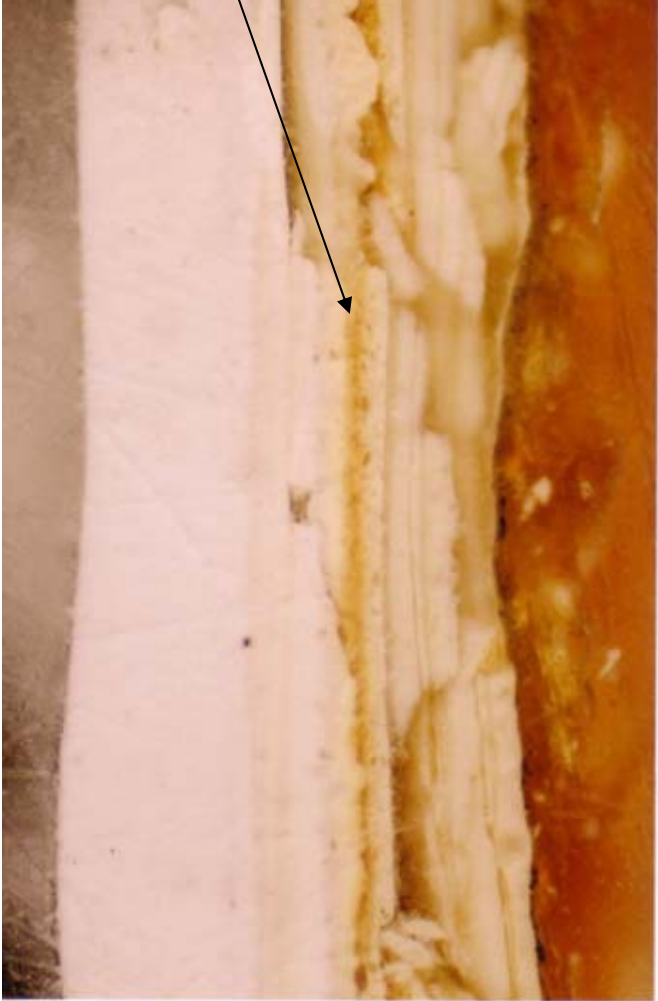
<p>8) white</p> <p>7) white</p> <p>6) white</p> <p>5) white</p> <p>5) dirt layer</p> <p>4) white</p> <p>3) white</p> <p>2) white</p> <p>1) substrate</p>	
<p><i>Comments: The darker horizontal and vertical lines indicate paint flaking and breakage.</i></p>

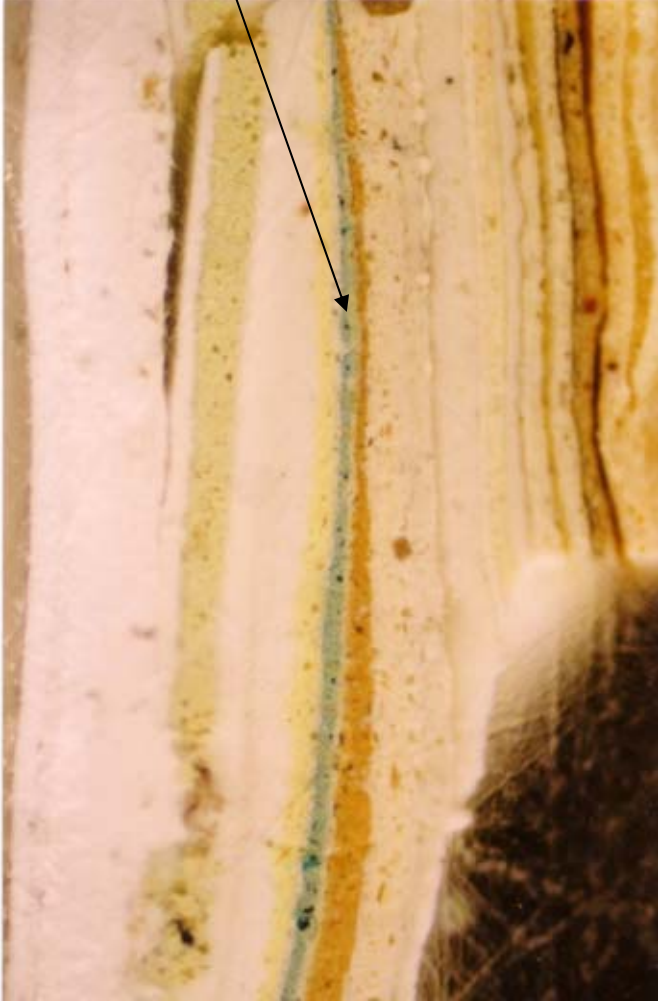
<ul style="list-style-type: none"> 15) white 14) white 13) cream-grey 12) white 11) pale yellow 10) pale mint green 9) light brown-yellow 8) off white 7) off white 6) off white 5) off white 4) white 3) off white 2) light brown-yellow 1) off white 	
<p><i>Comments:</i> Voids in Layers #1 & #12 reveal paint cracking. The substrate and primer layers, below Layer #1, are not included in the photograph.</p>
